# **INDOOR AIR QUALITY ASSESSMENT**

**Whitin Middle School  
120 Granite Street  
Uxbridge, Massachusetts**

Prepared by:  
Massachusetts Department of Public Health  
Bureau of Environmental Health Assessment  
Emergency Response/Indoor Air Quality Program  
December 2003

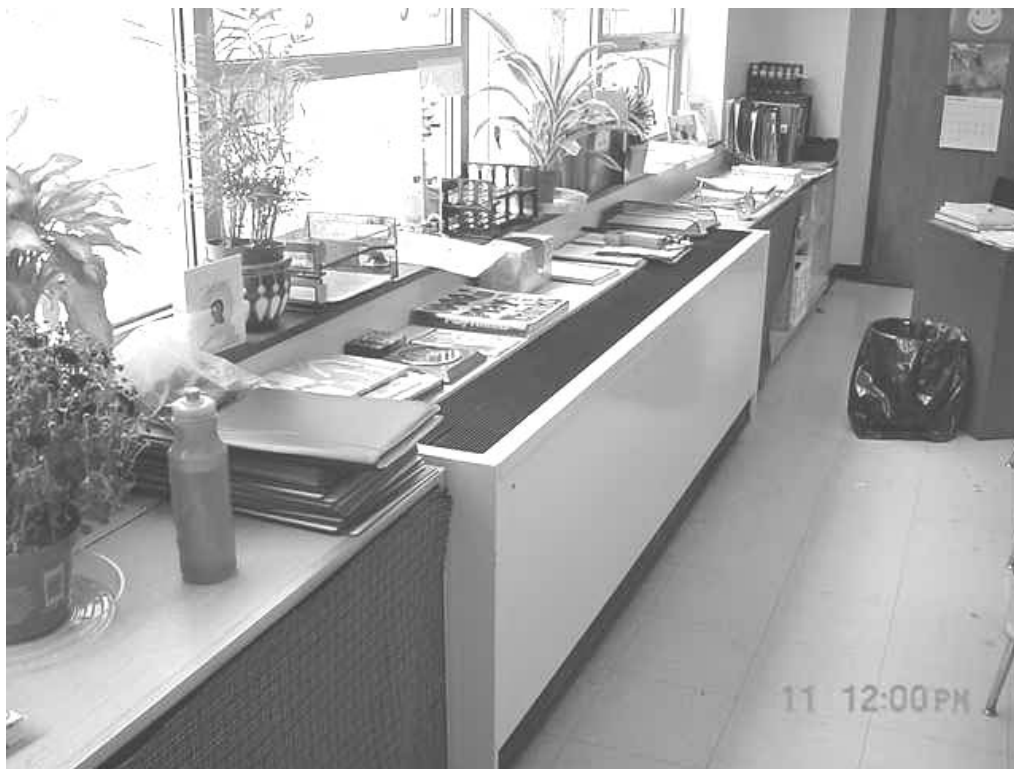
Picture 1

Fresh air in classrooms is supplied by a unit ventilator (univent) system (Picture 1). Univents draw air from outdoors through fresh air intakes located on the exterior walls of the building and return air through an air intakes located at the base of each unit ([Figure 1](#)). Fresh and return air are mixed, filtered, heated and/or cooled and provided to classrooms through a diffuser located on the top of the unit. Adjustable louvers control

Univents were deactivated in a number of classrooms throughout the school. Obstructions to airflow, such as furniture located in front of and/or materials stored on univents, were observed (Picture 1). In order for univents to provide fresh air as designed, these units must remain activated and allowed to operate while rooms are occupied. In addition, air diffusers and return vents must remain free of obstructions.

4. Examine each univent for function. Survey classrooms for univent function to ascertain if an adequate air supply exists for each room. Operate univents while classrooms are occupied.

5. Continue with plans to repair rooftop exhaust motor. Consider contacting an HVAC engineering firm for advice to improve exhaust ventilation.
6. Remove all blockages from univents and exhaust vents.

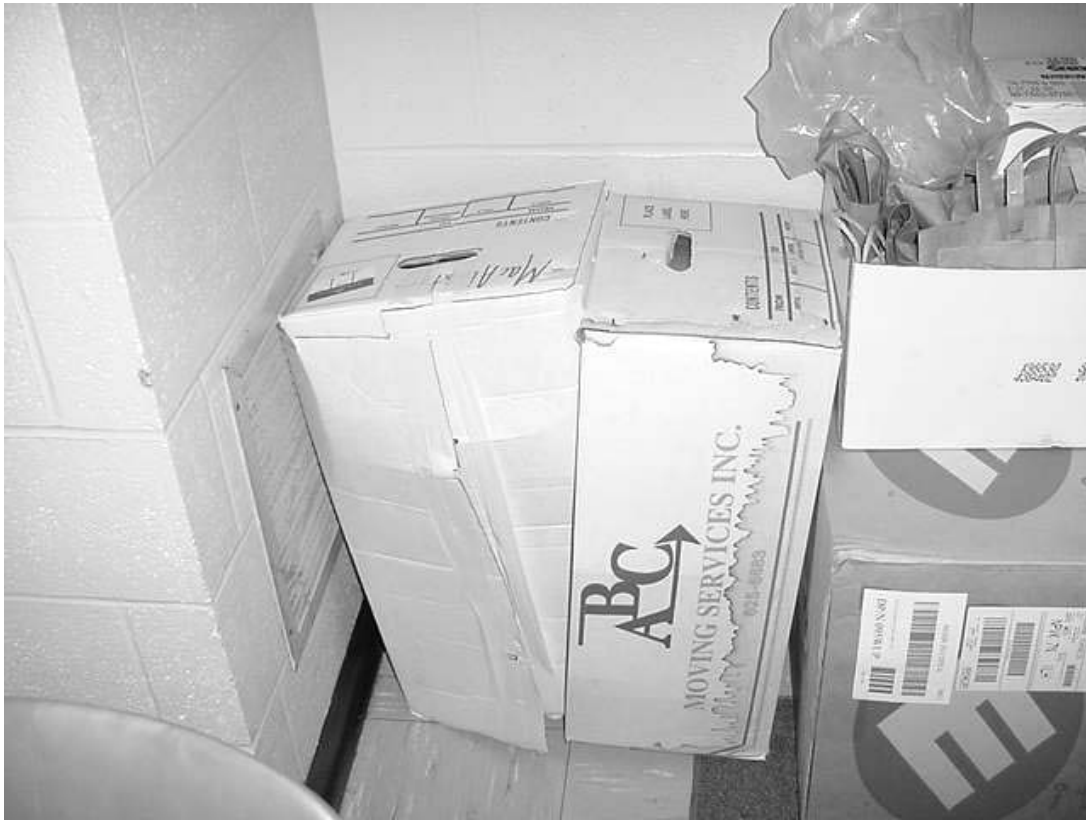
**Picture 2**

Lastly, wall vents were blocked by desks, cabinets, and other furniture (Picture 2). As with univents, in order for exhaust ventilation to function as designed, they must be

activated and remain free of obstructions. Without supply and exhaust ventilation, indoor air pollutants can build up and lead to indoor air quality/comfort complaints.

**Classroom Exhaust Vent Partially Obstructed by Boxes**

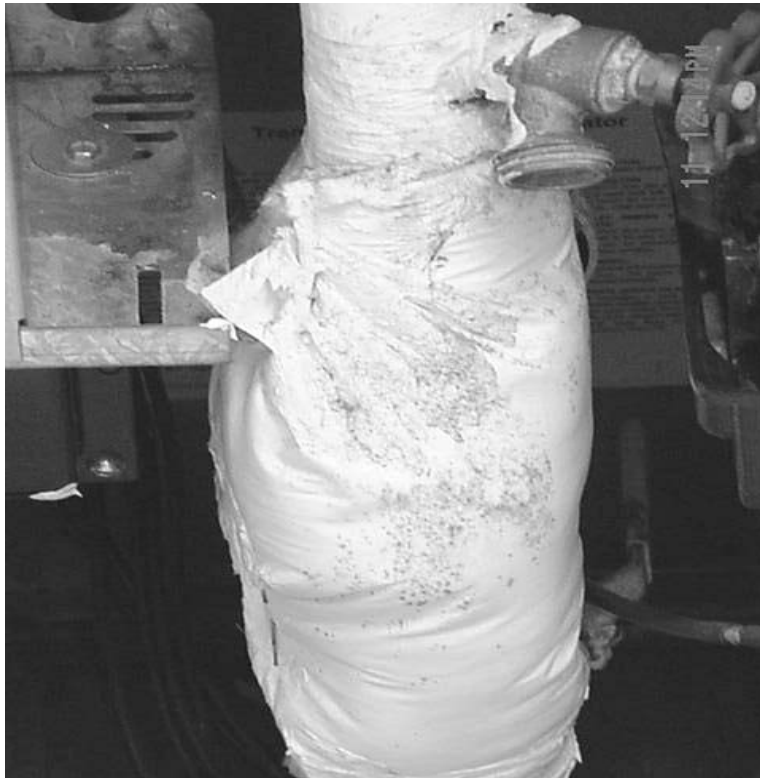
**Picture 3**

**Mold Colonization (Dark Stains) on Univent Pipe Insulation**

- Physical cleaning of all non-porous surfaces (e.g., chairs, tables, desks) colonized with mold using a bleach and water solution, followed by wet wiping with a soap and water solution.
- Replacement of mold-colonized pipe insulation.
- Inspection and/or removal of all non-porous materials (e.g. books, papers) for microbial growth.
- Replacement of water damaged/mold colonized ceiling tiles.

1. Continue to examine pipe insulation in the interior of univents for microbial growth, remove and replace as necessary.
2. Continue to work with concerned individuals to identify and address IAQ/mold concerns. Should mold issues recur, remove mold-contaminated materials in a manner consistent with recommendations found in “Mold Remediation in Schools and Commercial Buildings” published by the US Environmental Protection Agency (US EPA, 2001). Copies of this document can be downloaded from the US EPA website at: [http://www.epa.gov/iaq/molds/mold\\_remediation.html](http://www.epa.gov/iaq/molds/mold_remediation.html).
3. Operate both supply and exhaust ventilation continuously during periods of school occupancy independent of classroom thermostat control.

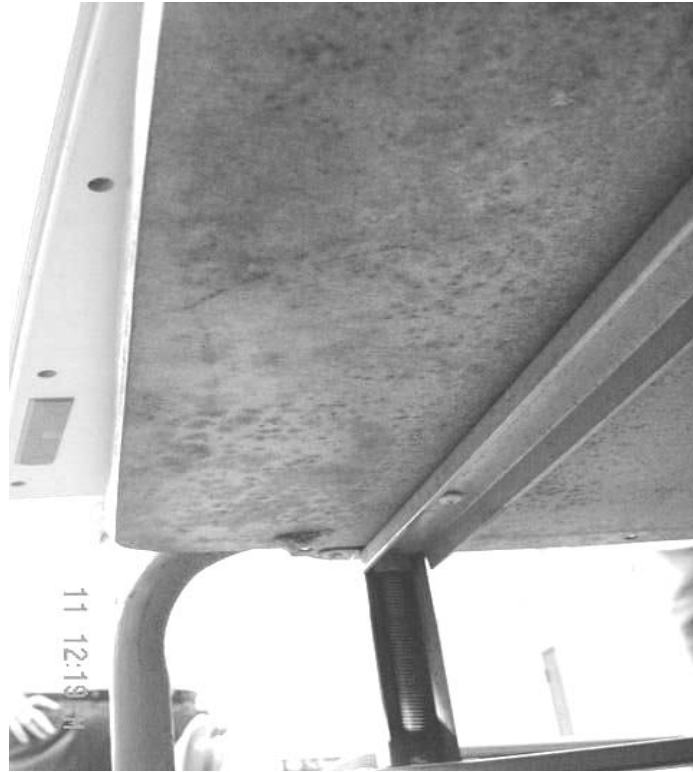
**Picture 4**

The materials listed in Table 1 were noted as either colonized with mold or in contact with mold spores. The majority of materials in the building that were colonized with mold were removable materials (e.g., books, desks, ceiling tiles and insulation) that can be cleaned or discarded/replaced (Pictures 3-6). Visible mold growth was noted primarily on non-porous surfaces (e.g., floors, desks, and chairs) constructed of materials that are not likely to be colonized by mold. Rather, these non-porous surfaces were coated with materials (e.g., dust) that can support microbial growth if exposed to moisture for extended periods of time. Therefore, cleaning of non-porous surfaces should remedy the mold contamination problem within the WMS. In contrast, porous materials (e.g., boxes, books, insulation and ceiling tiles) should be removed/replaced to prevent further mold contamination problems.

**Mold Colonization (Dark Stains) on Underside of Desk**

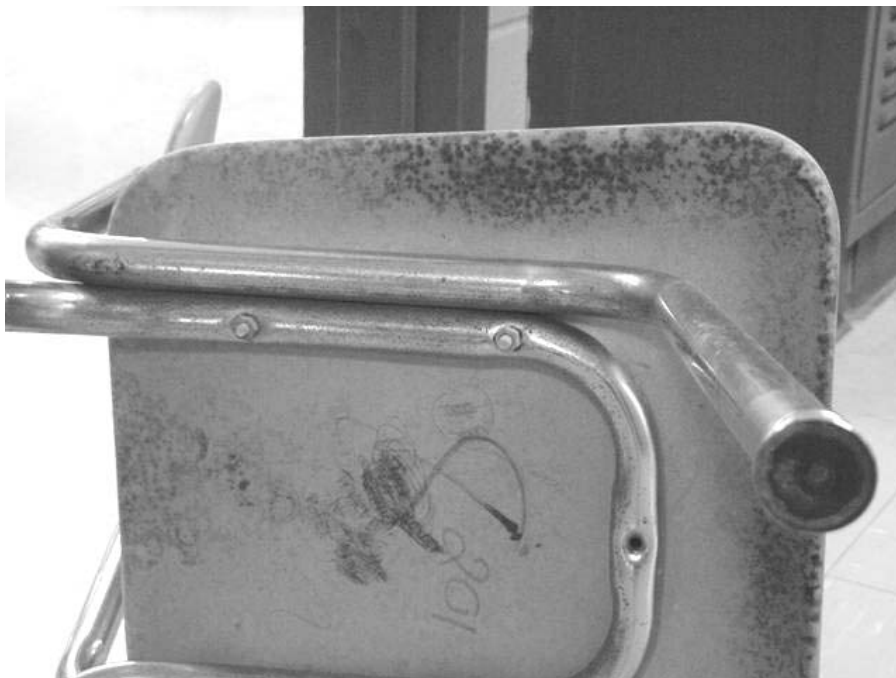
**Picture 5**

**Mold Colonization (Dark Stains) on Underside of Chair**

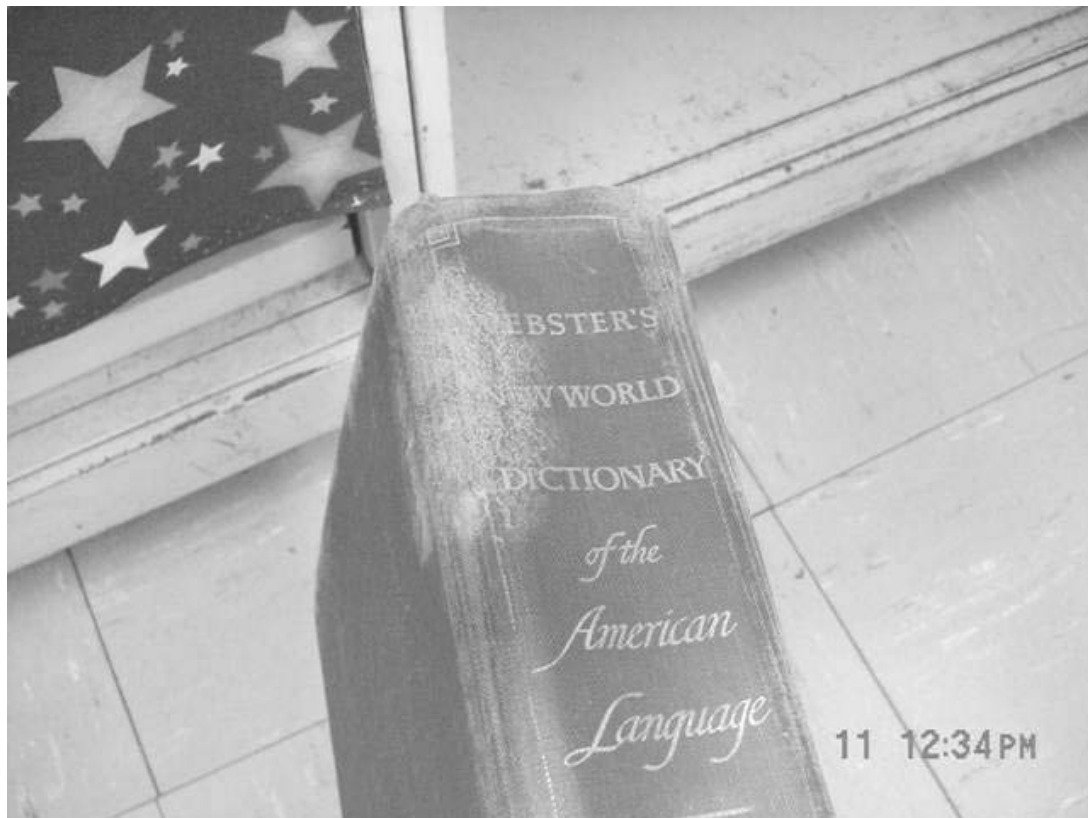
**Picture 6**

**Mold Growth on Textile Book Surface**

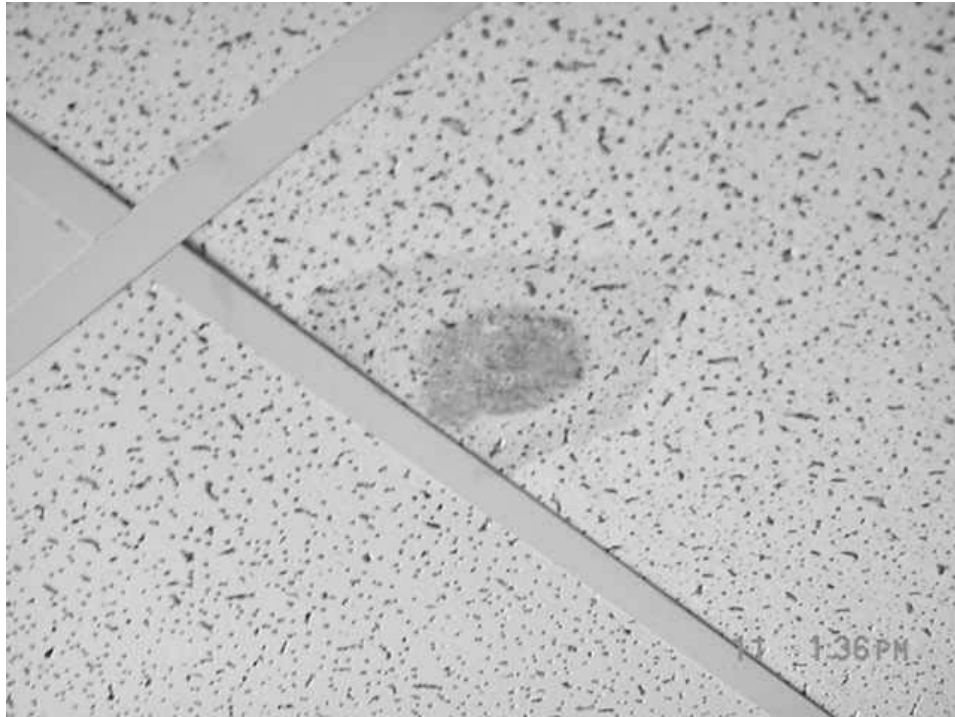
**Picture 7**

As previously noted, some water damaged ceiling tiles in 6<sup>th</sup> grade classrooms, as well as ceiling tiles in the guidance/health suite had visible mold growth (Table 1/Picture 7). Hallways and classrooms in other portions of the building also had water damaged

ceiling tiles. These ceiling tiles appear to have sustained damage from leaks in the air conditioning/drainage system rather than from excessive humidity.

**Water Damaged Ceiling Tile in Health/Guidance Suite**

8. Replace/repair any remaining water-stained ceiling tiles and building materials. Examine the area above and around these areas for mold growth. Disinfect areas of water leaks with an appropriate antimicrobial.

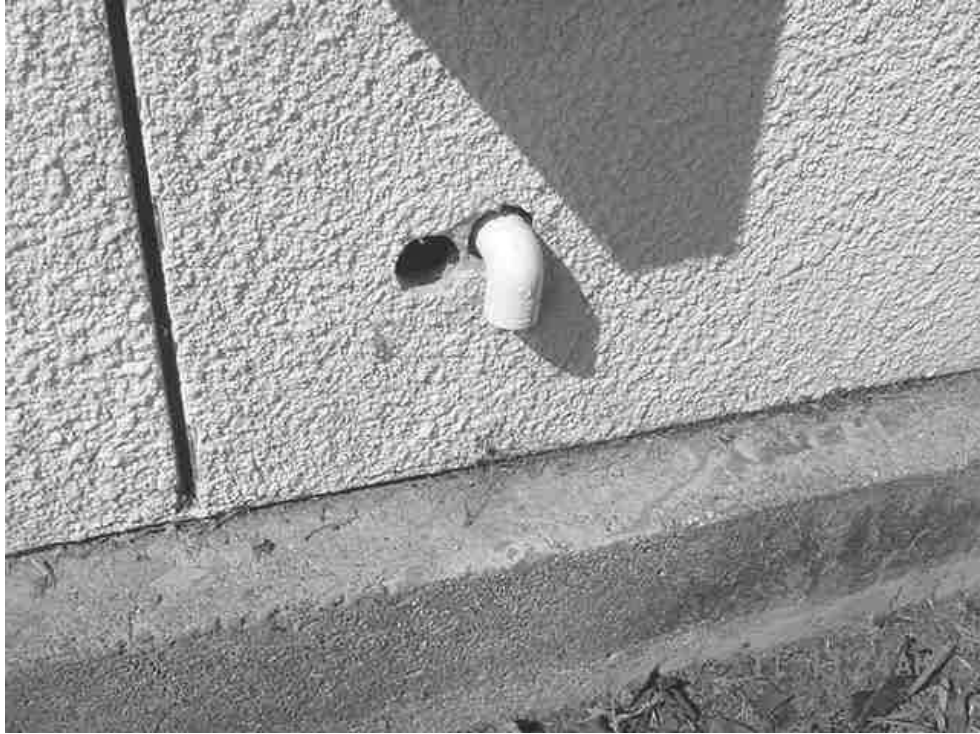
**Picture 8**

A potential pathway for moisture into the building includes open utility holes in exterior walls (Picture 8). Several classrooms had open utility holes, which appeared to have been drilled for univent condensation drains. These holes are breaches to the building envelope that can allow water penetration into the building. Repeated water penetration can result in the chronic wetting of building materials and potentially lead to microbial growth. In addition, these large wall cracks/holes may provide a means of egress for pests/rodents into the building.

**Open Utility Hole in Exterior Classroom Wall**

12. Seal holes in exterior walls to prevent water intrusion.

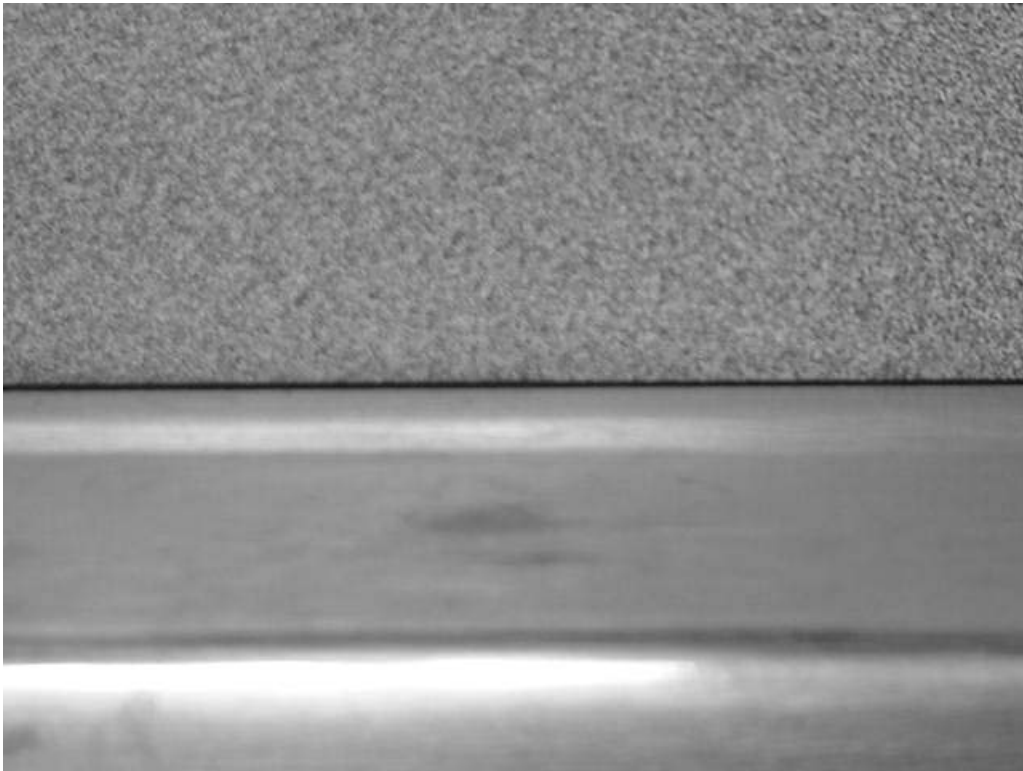
**Picture 9**

Lastly, spaces between the sink countertop and backsplash were noted in a number of classrooms (Picture 9). Improper drainage or sink overflow can lead to water penetration. If the seam is not watertight, water can penetrate and collect behind the

countertop or within cabinets. Like other porous materials, if these materials become wet repeatedly they can provide a medium for mold growth.

Space between Sink and Counter

13. Seal areas around sinks to prevent water-damage to the interior of cabinets and adjacent wallboard. Inspect wallboard for water-damage and mold/mildew growth, repair/ replace as necessary. Disinfect areas with an appropriate antimicrobial, as needed.

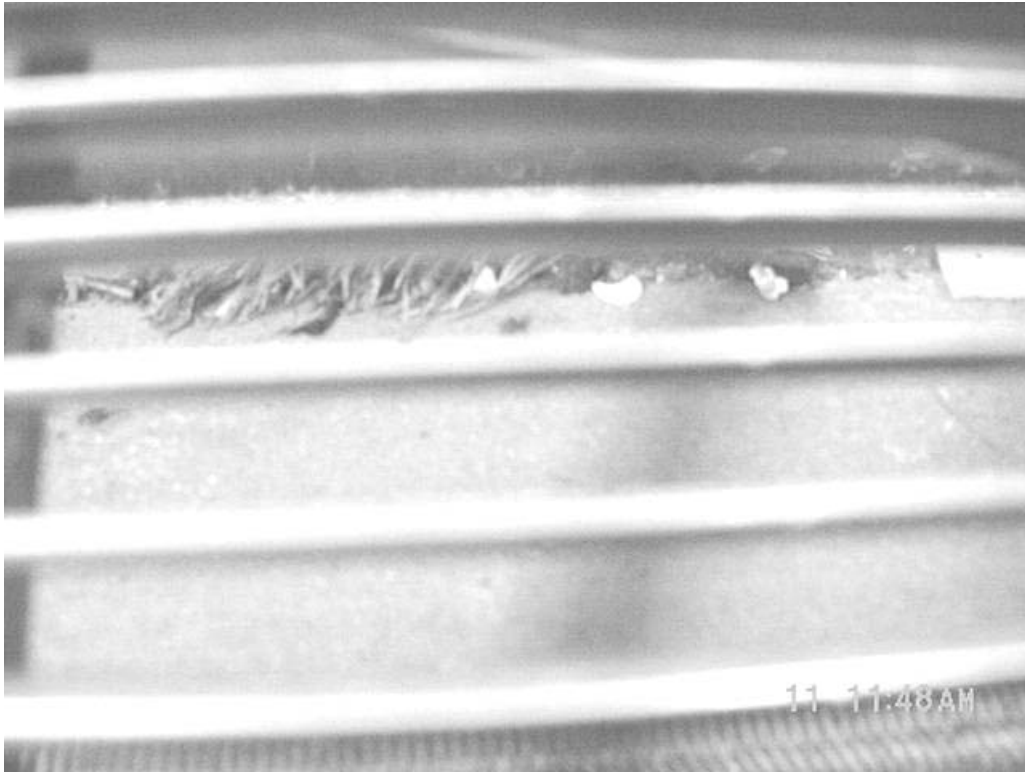
**Picture 10**

Several other conditions that can affect indoor air quality were noted during the assessment. A number of univents had accumulated dirt, dust and debris within the air handling chambers and diffusers (Picture 10). Dust can be irritating to the eyes, nose and respiratory tract. In order to avoid this equipment serving as a source of aerosolized particulates, the air handling sections of the univents should be cleaned regularly (e.g., during regular filter changes).

**Dirt, Dust and Debris in Univent Air Diffuser**

16. Clean univent air diffusers and exhaust vents periodically of accumulated dust.
17. Refrain from using strong scented materials (e.g., air fresheners) in classrooms.

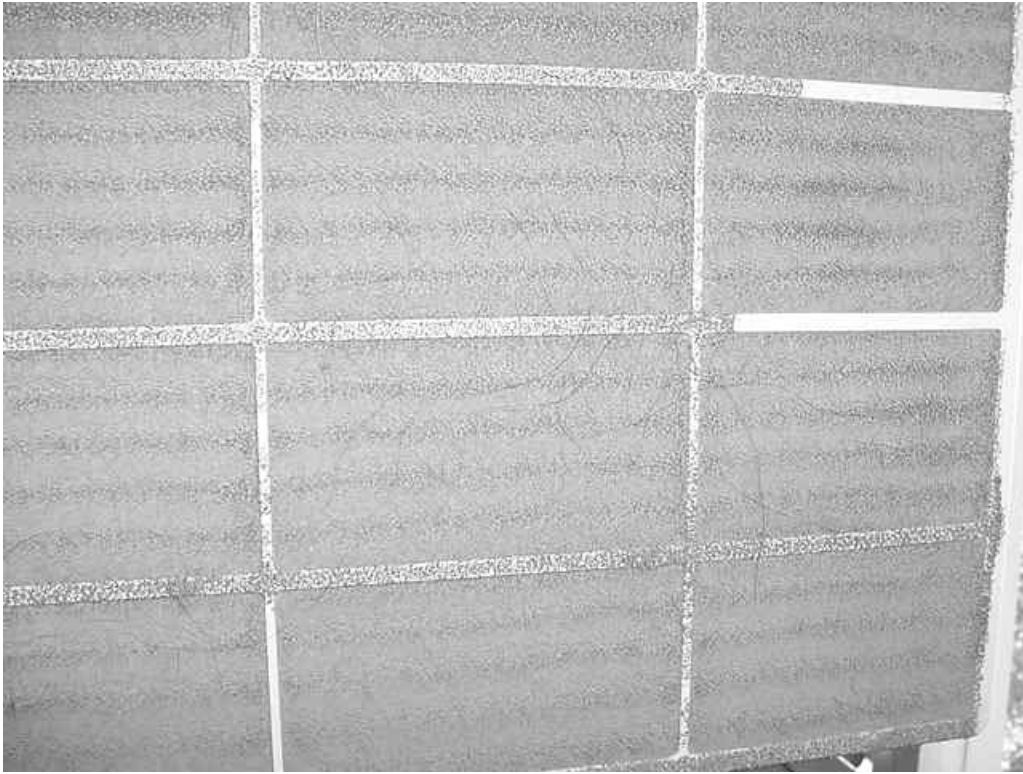
**Picture 11**

In addition, two window-mounted air conditioners were located in the computer room. This equipment is normally fitted with filters. Filters for both air-conditioners were occluded with dust (Picture 11). To avoid the build up and re-aerosolization of dirt, dust and particulate matter, filters should be cleaned or changed as per manufacturer's instructions.

**Dust Accumulated on Air Conditioner Filter**

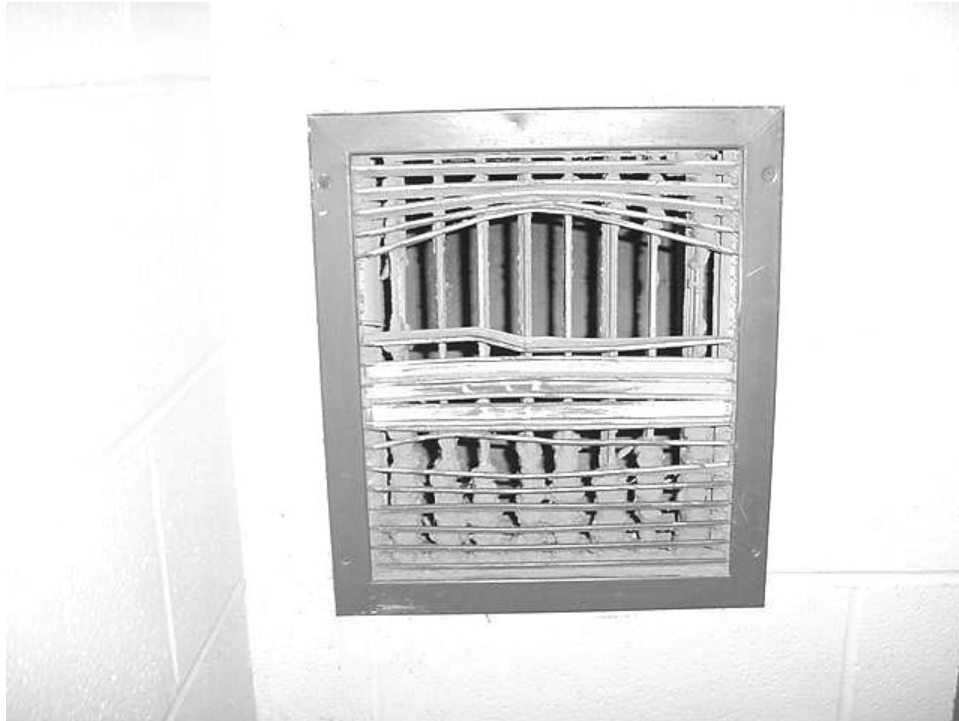
**Picture 12**

Furthermore, a number of exhaust vents in classrooms were noted with accumulated dust (Picture 12). If exhaust vents are not functioning, backdrafting can occur, which can re-aerosolize accumulated dust particles.

**Damaged Exhaust Vent With Accumulated Dust**

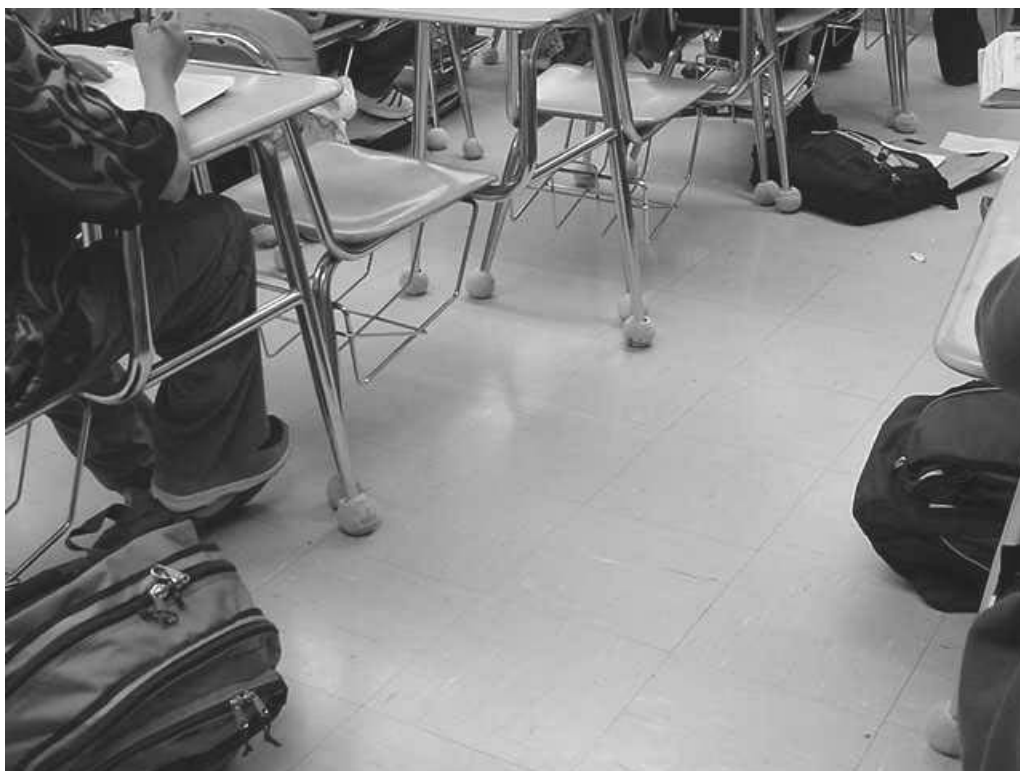
**Picture 13**

In an effort to reduce noise from sliding chairs, tennis balls had been cut open and placed on chair legs (Picture 13). Tennis balls are made of a number of materials that are a source of respiratory irritants. Constant wearing of tennis balls can produce fibers and cause off-gassing of VOCs. Tennis balls are made with a natural rubber latex bladder, which becomes abraded when used as a chair leg pad. Use of tennis balls in this manner may introduce latex dust into the school environment. Some individuals are highly allergic to latex (e.g., spina bifida patients) (SBAA, 2001). It is recommended that the use of materials containing latex be limited in buildings to reduce the likelihood of symptoms in sensitive individuals (NIOSH, 1997). A question and answer sheet concerning latex allergy is attached as [Appendix II](#) (NIOSH, 1998).

**Tennis Balls on Chair Legs**

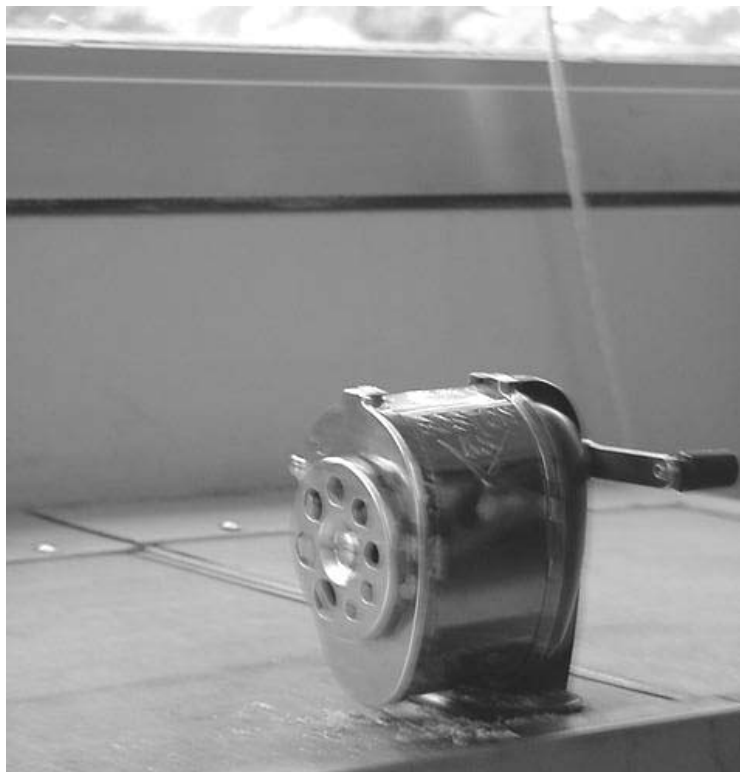
**Picture 14**

Lastly, pencil shavings were observed to be accumulating at the base of pencil sharpeners, which in many classrooms are stationed on bookcases located in front of windows (Picture 14). When windows are opened, pencil shavings can become airborne, providing a source for eye and respiratory irritation.

**Pencil Shavings Accumulated at Base of Sharpener**
